DETECTION OF INTERGRANULAR CORROSION IN COLD PLATE FACE SHEETS

William P. Winfree, Stephen W. Smith, Robert S. Piascik, Patricia A. Howell
NASA Langley Research Center,
Hampton, VA

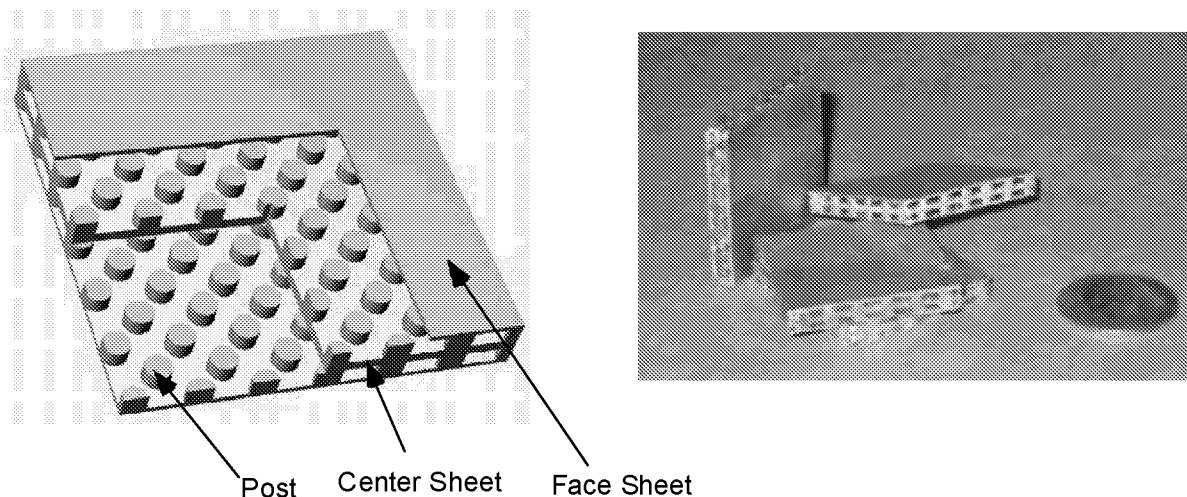
A diagram showing a typical region of the cold plates is shown in Figure 1. The largest area of the cold plates consists of three separate sheets separated by posts. The cooling fluid flows around the post and is contained between the two face sheets. The cold plates are fabricated from aluminum (AA6061). During fabrication, a 1000°F brazing process was used to bond the face sheet to the posts of the cold plates. Following the brazing, the cold plate components are slowly cooled to avoid distortion of the bonded cold plate. This slow cooling process causes excessive grain boundary precipitation resulting in a material that is susceptible to intergranular attack (IGA). The IGA is likely caused by an aggressive crevice environment created from condensed water vapor located between the cold plate and support shelf.

The specimens used in this effort were obtained by sectioning a portion of one of the flight hardware cold plates that had been taken out of service¹. This portion was sectioned into specimens approximately 1 inch by 1 inch. This size optimized the use of the cold plate and produced specimens that could easily be imaged with the microfocus tomography system. Some of the specimens used in this effort are shown in the photograph in Figure 1.

Figure 1. Diagram of typical portion of the specimen and photograph of several of the specimens with induced corrosion.
